TERRA CONTRACTING INC.

FIRE HYDRANT VALVE COLLAR REPAIR

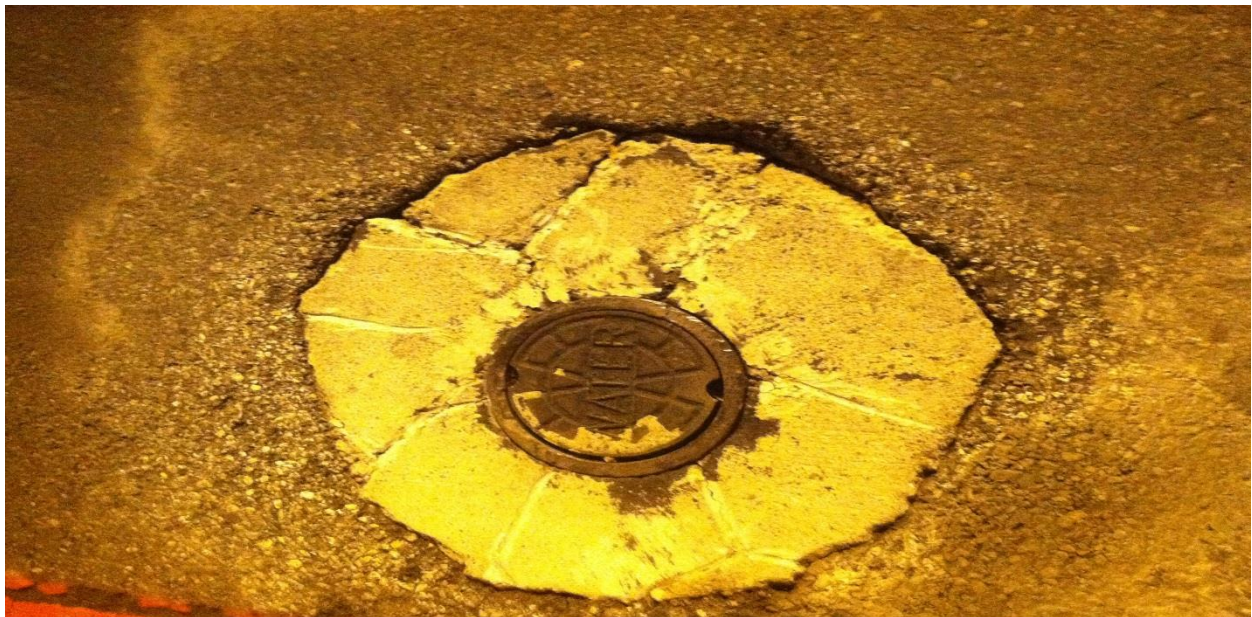
This concrete collar was damaged due to heavy delivery truck traffic. The smaller cracks were ground out and enlarged with a 4" grinder and a metal grinding wheel. A thin coating of primer was applied and followed by the application of a 3:1 (3 sand 1 FlexKrete) mixture of FlexKrete. The mix was troweled into the cracks as well as across the concrete collar.
